INFORMATION REPORT

Military Camp at Eger

[redacted] Memory sketch of the Military Camp at Eger

Sketch of the Military Camp in Eger

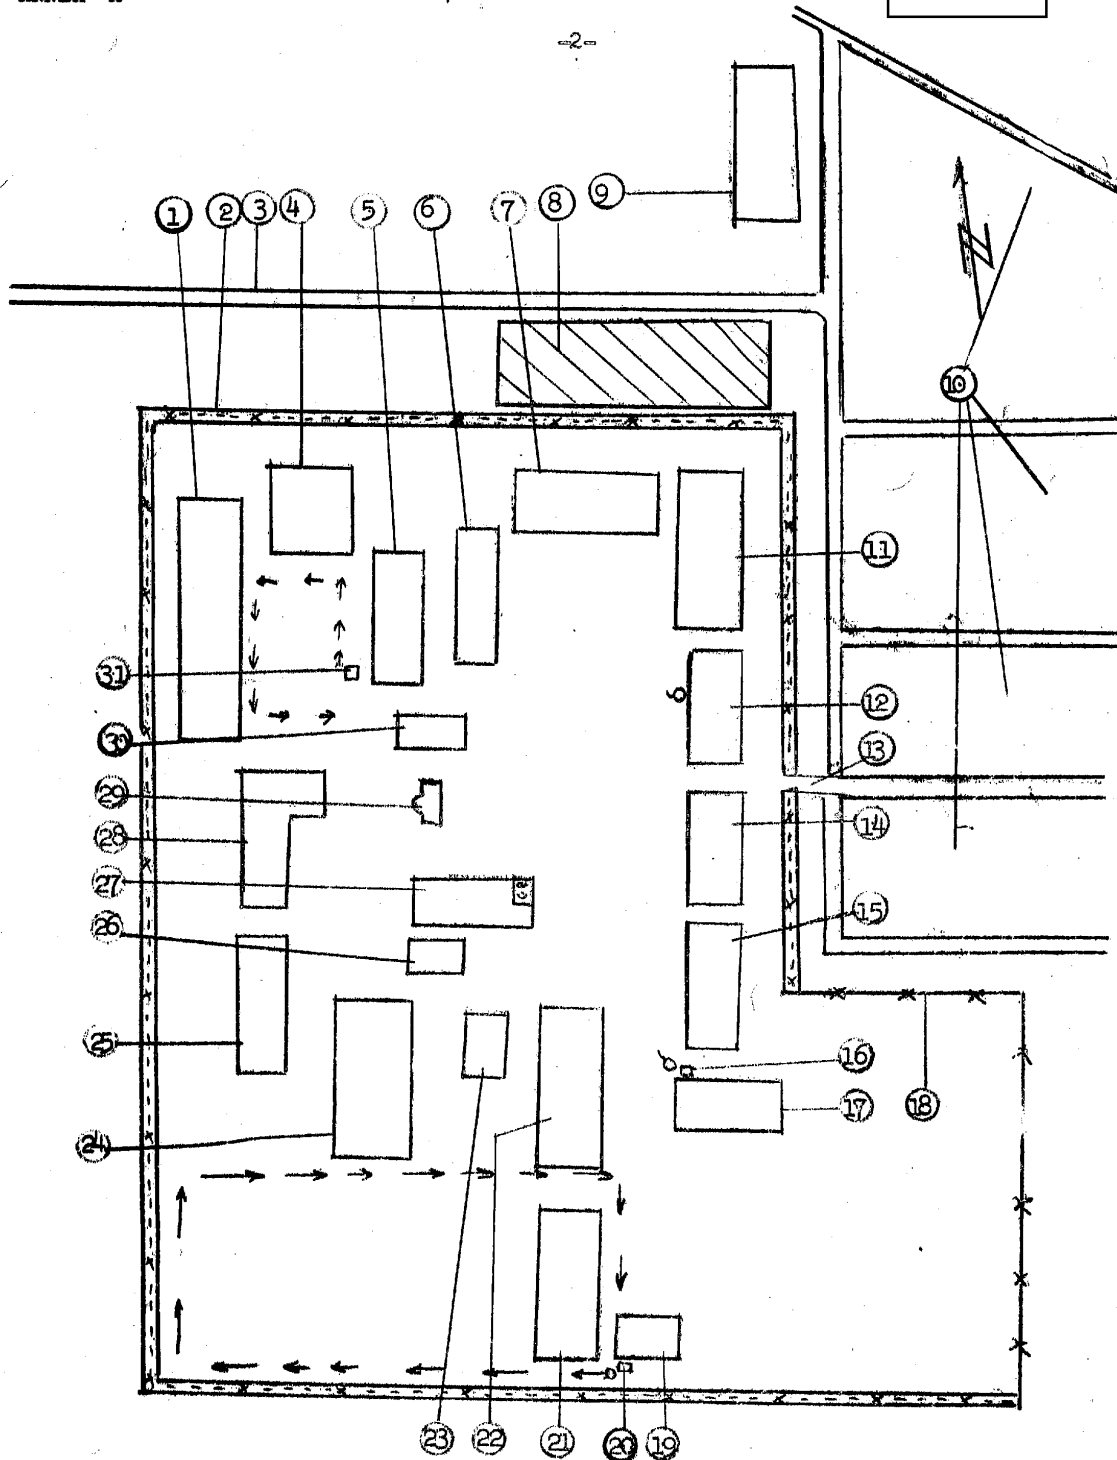
1. Supply building, single story, brick construction, 38 x 10 x 8 m., hipped tile roof. Windows and doors along east side only. Building used as clothing issue point.

2. Wall, brick, four meters high, 1½ m. thick, three strands of barbed wire on top.
3. Road, third class, dirt, used by troops to go to maneuver area and to adjacent obstacle course.

4. Supply building, single story, brick construction, 20 x 10 x 8 m., hipped tile roof. Used to house small arms, rifles, Tommy guns, machine guns, which were stored and available for issue. The armament stored here could supply 300 men.

5. Supply building, single story, reinforced concrete construction, 18 x 10 x 8 m. Flat deck type roof. Used to store small caliber ammunition, hand grenades and rifle ammunition.

6. Repair shop and prison, single story, brick construction, 18 x 10 x 8 m., hipped tile roof. North end used to repair pistols, rifles, Tommy guns, with eight soldiers working five days a week. Prison was in south end of building. Eight rooms, windows barred.

7. Barracks, brick construction, 30 x 10 x 25 m., hipped tile roof, three stories, windows on all sides of all three floors, basement under entire building. Used as class rooms for instruction in pistols, rifle and submachine guns.

8. Obstacle course, area 50 x 20 m. Used by all troops three or four times per week, one to three hours each period. Obstacles very similar to US type.

9. Dispensary building, three story, brick construction, 30 x 10 x 25 m., hipped tile roof, 40 bed capacity, two permanent doctors. Very poor medical services were provided.

10. Eger. Small family-type quarters in this part of town. Adjacent roads were cobblestone, three to four meters wide, in good condition.
11. Barracks, three stories, brick construction, 30 x 10 x 25 m., hipped tile roof, basement under entire building. First Battalion troop barracks -- 400 men.

12. Headquarters building, three story, brick construction, 20 x 8 x 25 m., hipped tile roof. Regiment Headquarters and staff offices. Basement.
13. Gate, heavy wire, kept closed, with guard posted 24 hours. Passes and orders were carefully checked upon leaving camp.

14. Barracks building, three stories, brick construction, 20 x 8 x 25 m., hipped tile roof. First floor used as visitors' reception center. Second and third floors were troop quarters. Basement.

15. Barracks building, three stories, brick construction, 20 x 8 x 25 m., hipped roof, basement. Troop barracks -- 350 men.
16. Guards and guard house. The entire camp guard consisted of eight sentries, posted 24 hours a day on four-hour shifts, equipped with Tommy guns and automatic rifles. There were four guard houses, one man type.

17. Building, two stories, reinforced concrete construction, 18 x 8 x 20 m., flat deck type roof. Used as headquarters offices for 2nd and 3rd battalions. This building housed both battalion commanding officers.

18. Fence, heavy wire, three-four strands on top, 3.5 m. high.
19. Storage building, single story, reinforced concrete construction, 10 x 6 x 8 m., flat deck type roof. Used for small arms storage.

20. Guard and guard house, same as Point #16, this report.
21. Barracks, three stories, reinforced concrete construction, 30 x 10 x 25 m., flat deck type roof. 3rd Battalion troop barracks.

22. Barracks, three stories, reinforced concrete construction, 30 x 10 x 25 m., flat deck type roof. 2nd Battalion troop barracks.
23. Mess hall, single story, reinforced concrete construction, 20 x 15 x 8 m., flat deck type roof. Used by 2nd and 3rd Battalion troops.

24. Assembly hall, single story, reinforced concrete, 30 x 14 x 8 m., flat deck type roof.

25. Artillery storage building, single story, reinforced concrete construction, flat deck roof. Following type armament housed here: four 45 mm. M1937 AT Guns, two 57 mm. M1943, one 76 mm. M1942 AT Gun. All were in very poor condition, well worn from World War II usage.

26. Shower, single story, brick construction, 10 x 8 x 6 m., hipped tile roof.
27. Headquarters building, two stories, reinforced concrete construction, 18 x 18 x 8 m., flat deck type roof, occupied by 1st Battalion commanding officer and staff.

28. Mess hall, single story, brick construction, 18 x 10 x 8 m., hipped tile roof. Used as mess hall, kitchen and canteen for 300 men. The food was very poor, although better than the Officers Mess. I often ate at the enlisted men's mess because of the somewhat better quality of food. Dinner usually consisted of soup and soup meat with vegetables, but it was difficult to find very many pieces of meat in individual bowls. Supper was usually a cold meal consisting of cold cuts and black bread.

30. Officers' mess, one story, reinforced concrete construction, 10 x 6 x 10 m., flat deck roof. Fed about 40-50 officers. The food was much poorer than the enlisted men's mess and prices were considered high for meals. The Regimental commanding officer sat at his private table in the center of the room. The building also had a small sitting room and a small kitchen.

31. Guard and guard house, same as Point #16, this report.

[redacted]. The troops stationed there numbered between 1,200 and 1,300. The majority of buildings at the Camp were built during World War II. I know of no bomb damage. Buildings erected between April and November 1951 are points #17, 19, 21, 22, 23, and 24 of my memory sketch Annex A. See also [redacted].
